EFFECT OF ARSENIC ON MICROORGANISMS AND BIOFILMS IN MIC OF WATER NETWORK MATERIALS

S. Rastelli, M. Viera, B. Rosales

CIDEPINT, Argentina. brosales@fibertel.com.ar

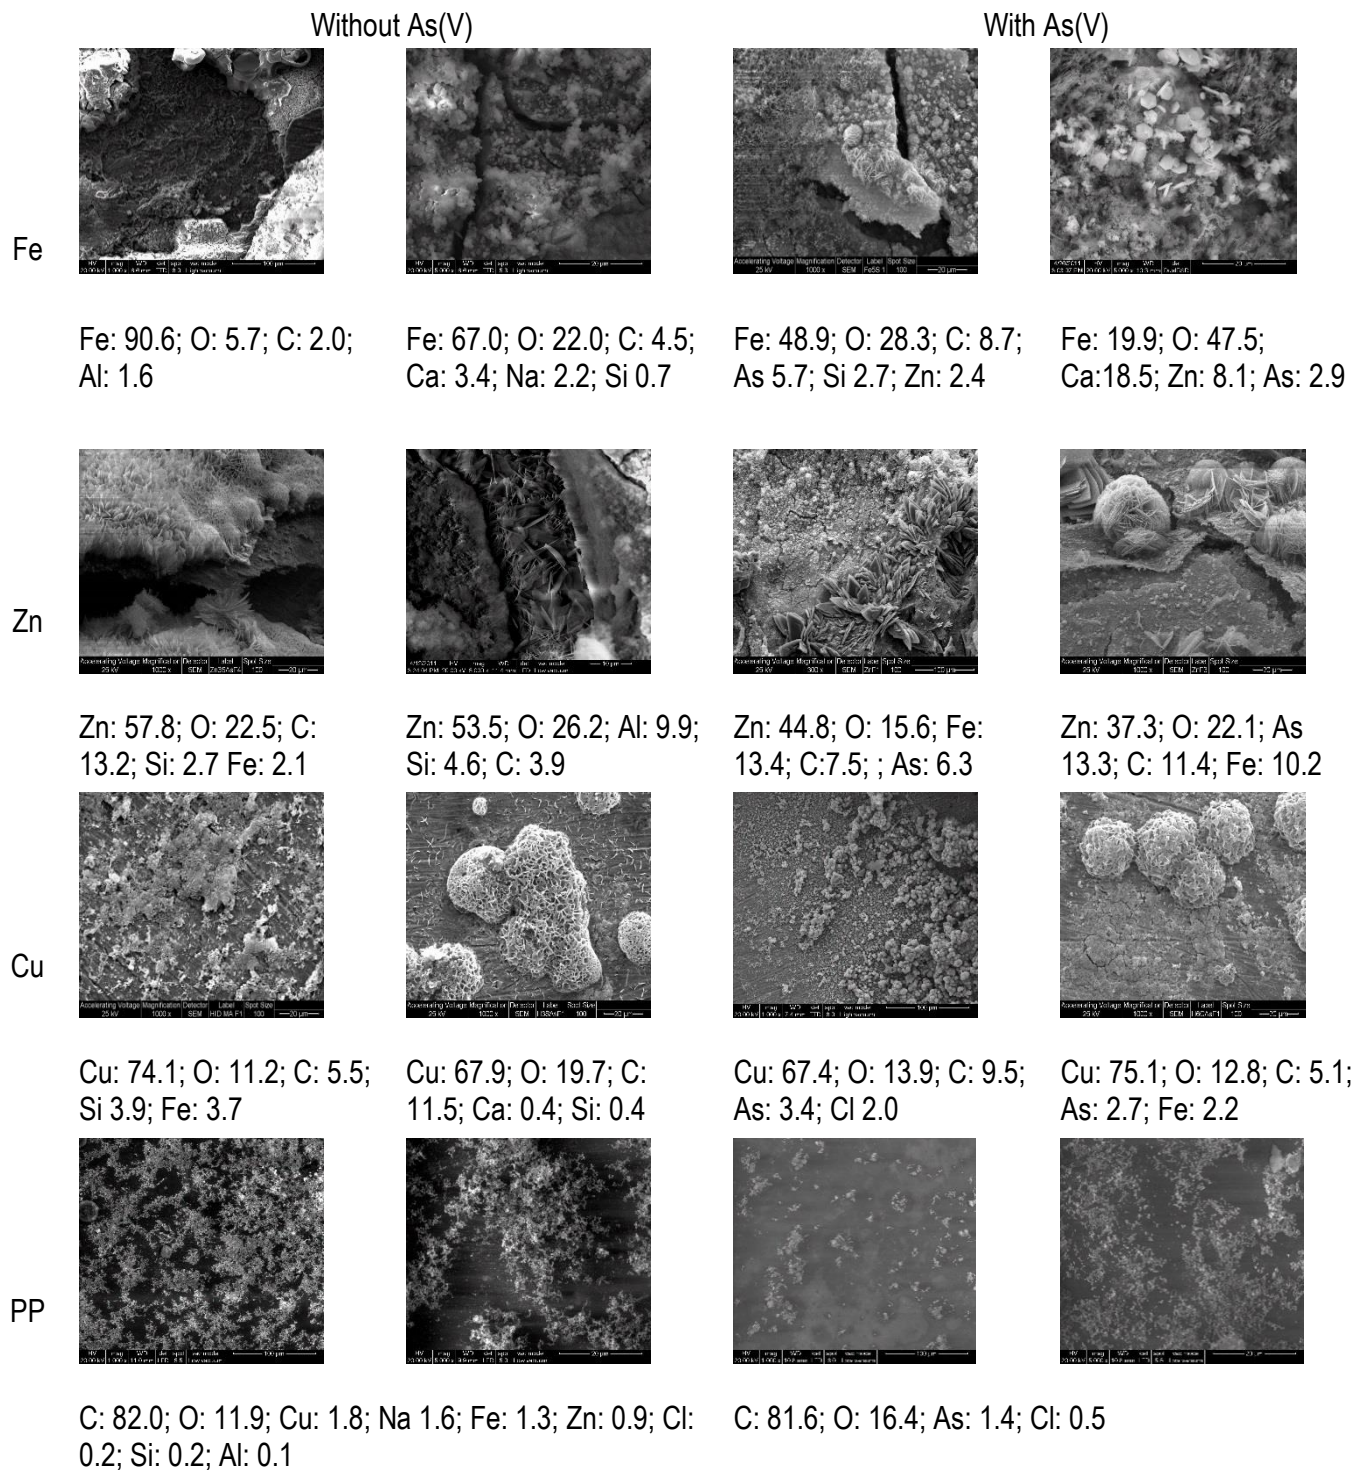
deposits showed a very heterogeneous distribution on all test samples. Figure 1 shows SEM micrographs for each material in both circuits.

Figure 1: SEM and EDS surface analysis of coupons exposed in both circuits.

Coupons in the presence of As(V) showed higher deposit accumulation on Fe and Zn samples. Arsenic was only detected in EDS in those areas covered by biofilms. The surface failures detected on PP near microbial cells were not attributed to microbial biodeterioration, but to the process of thermocompression applied. The attack morphology observed by SEM/ESEM after removal of the deposits was characteristic of localized MIC. This morphology seemed to depend more on the substratum and metallurgical structure than on biofilm characteristics. Fe and Zn showed hemispherical localized attack with corrosion products accumulating at the bottom, while localized attack on Cu revealed the alloy crystallography. The same results were observed in the presence of As.

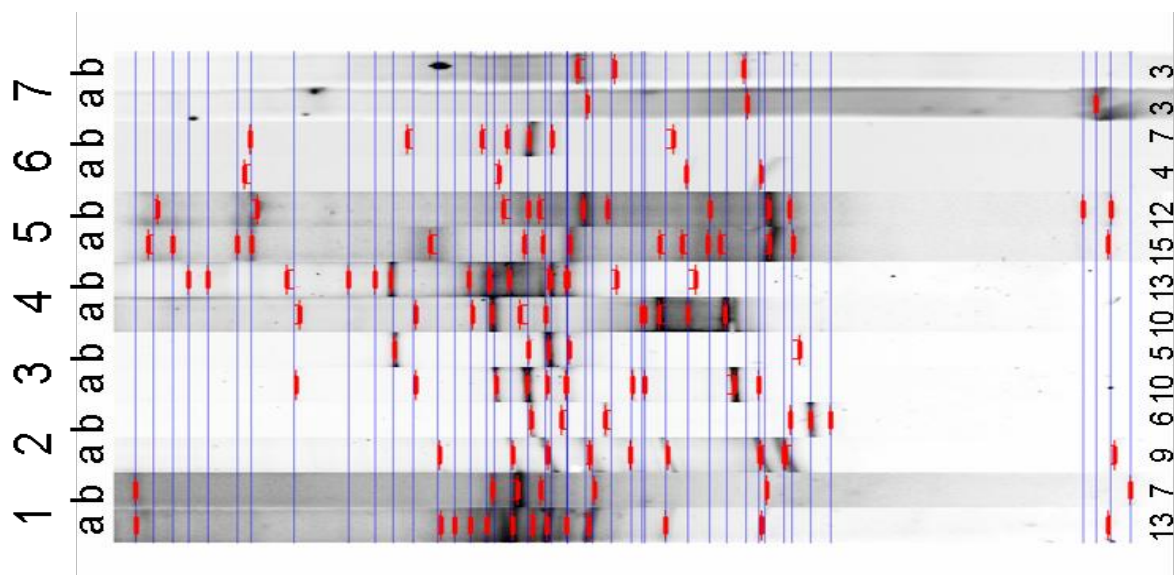
Figure 2 - DGGE fingerprint gel of 16S rRNA from DNA of the planktonic communities in seven independent runs in both circuits. On left, 1 to 7: number of run; a: without As, b: with As; On right: number of bands in each lane.

Microbial characterization. Direct PCR-DGGE of the total planktonic and sessile DNA allowed a description of the structure of microbial communities present in the water and in the biofilms. The number of DGGE bands was used as an indication of the number of dominant bacterial groups (Portillo and Gonzalez, 2008). Figure 2 illustrates the DGGE band patterns of planktonic communities present in both circuits in 7 independent runs. Each sample produced a distinctive molecular profile with a different number of bands of varying intensities, different from the profiles generated by any other sample. The different profiles at the end of each experiment indicated that the bacterial community was affected qualitatively (band position) and quantitatively (band intensity) by the presence of arsenic in the water. The diversity of the bacterial community was very variable. Several runs showed relatively high numbers, while other samples exhibited very few bands.

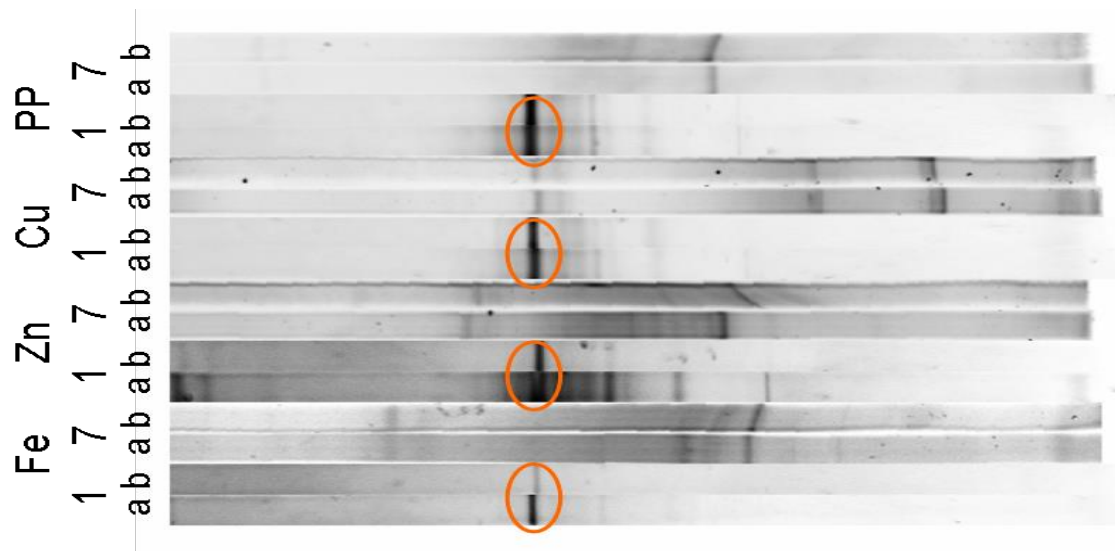
Figure 3 - DGGE fingerprint gel of 16S rRNA from DNA of sessile communities on Fe, Zn, Cu and PP; 1 and 7: selected runs for this analysis, a: circuits without As, b: circuits with As.

Profiles of the sessile communities formed on each material were obtained. Only series 1 and 7 yielded enough DNA from biofilms formed on all the substrata. In the other experiments some biofilms, particularly those formed on PP and Cu, contained too low a number of microorganisms for DNA extraction and PCR amplification. The profiles of the bacterial sessile communities growing on each substratum are shown in Figure 3. The community profiles on each substratum in the absence (lanes "a") or in the presence (lanes "b") of As(V) showed no significant difference (with the exception of biofilms on Zn in experiment 1). Thus, it could be concluded that the nature of the substratum is a more important factor for the establishment of the sessile community than the presence of arsenic.
